NOTES Site boundary Trial pit excavated by Mason Ryans Partnership (January 2013) Borehole sunk by Aitken Laboratories Limited (January 2013) Conjectured depth to suitable foundation horizon (m) (0.50m)		REV DATE DETAILS	
TP1 to TP9 Comp1 to Comp3 (0.50m)		PRO-CONSTRUCTION LIMITED 4 MOUNTBLATTEN PLACE ROSYTH KY11 2HL	
PROJECT TITLE GREYRIGGS CALIFORNIA, FALKIRK		DRAWING TITLE CONJECTURED DEPTH TO SUITABLE FOUNDATION HORIZON	
DRAWN BY PH	CHECKED BY G2012/356	DATE 09.05.13	SCALE 1:500 @ A4
PROJECT NO. G2012/356	DRAWING NO. G2012/356/SU/F/11	REVISION

12.0 MINING AND MINERAL EXTRACTION

Project: Greyriggs Reservoir Falkirk

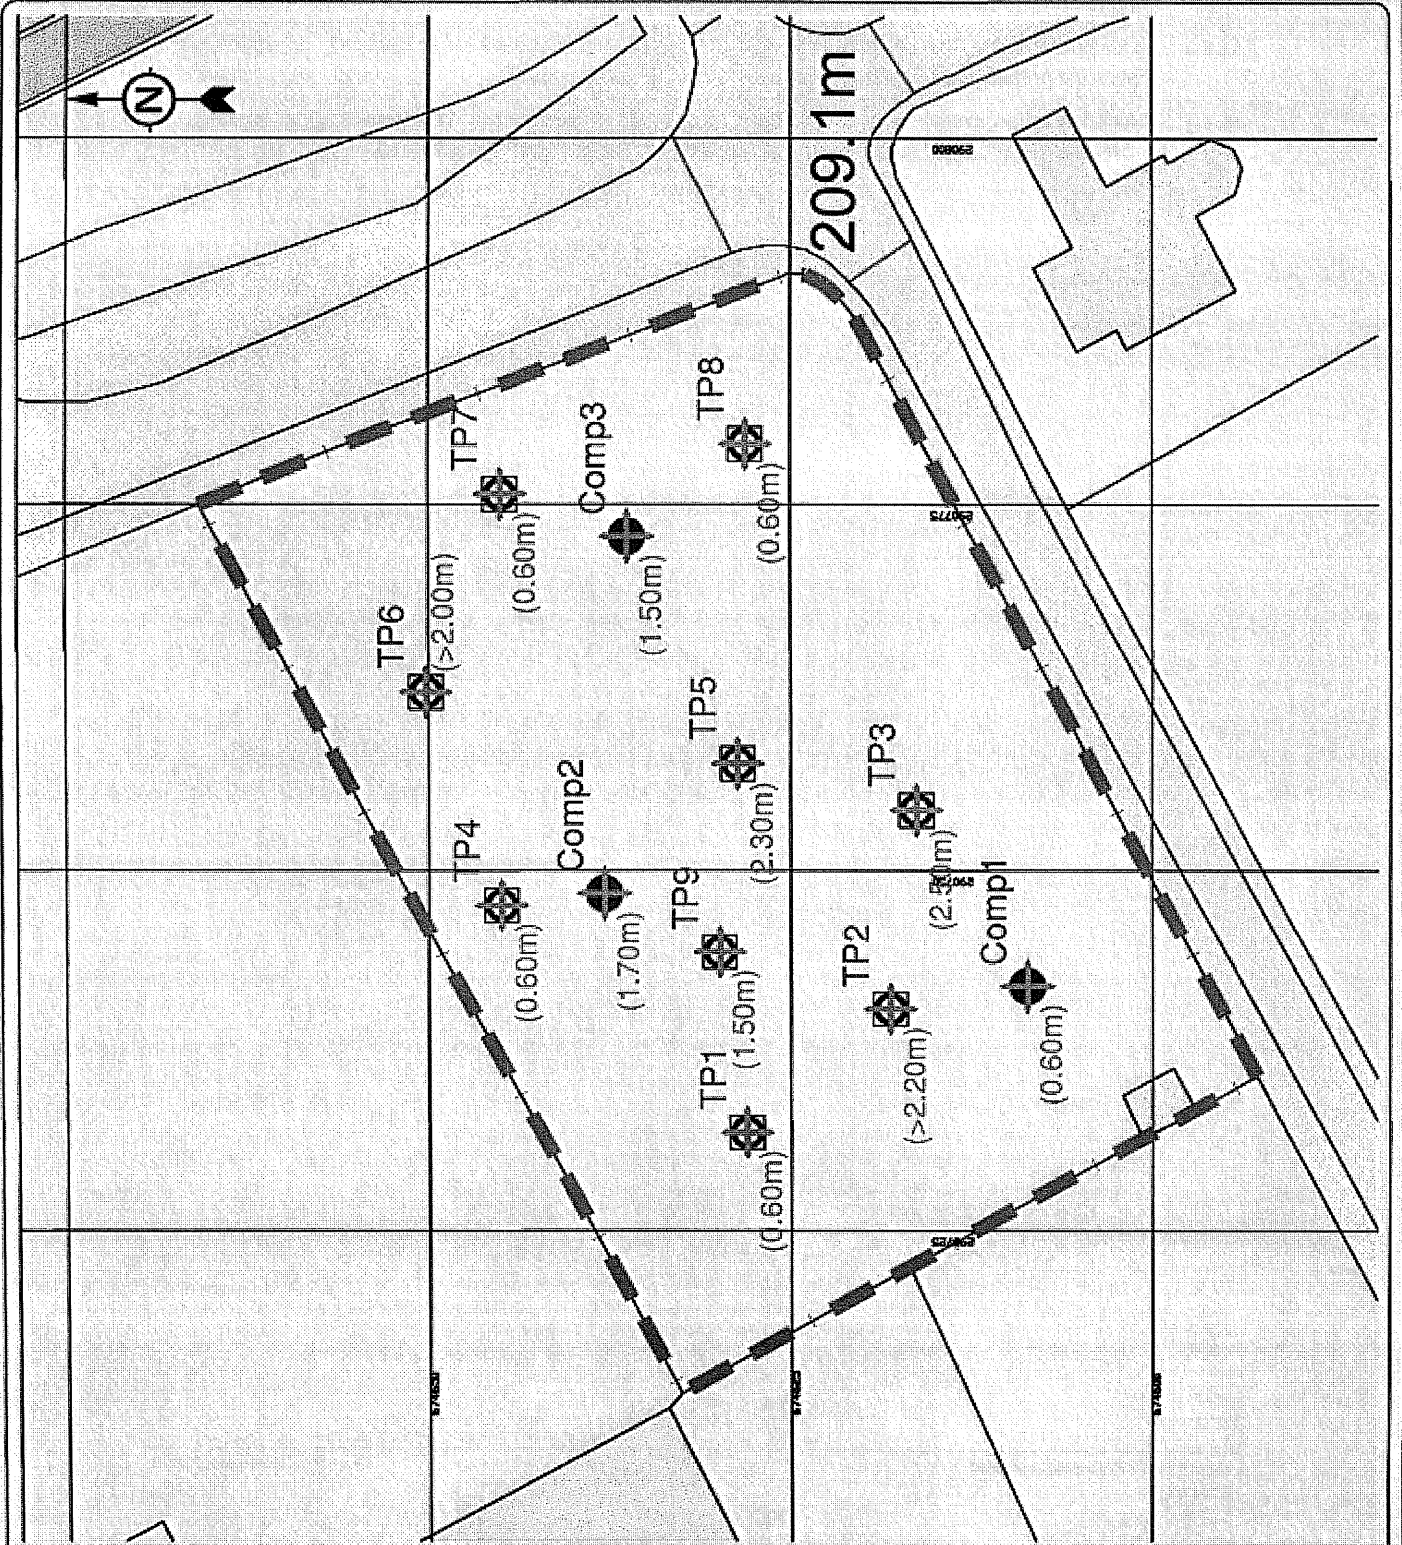
12.1.2 The geological assessments indicated that the shallowest recorded mineral seam below the site is the Lower Drumgray Coal, which is indicated to be 1.5m in thickness and lie at depths in excess of approximately 20m below the area. The rotary borehole drilled at the site recorded rockhead 19.8m to 21.5m. All boreholes recorded solid strata with the exception of borehole R3 which recorded a void from 21m to 23m. This is interpreted to be workings in the Lower Drumgray Coal.

12.2.1 The site was indicated to be within an area of known mineworkings. The Lower Drumgray Coal is recorded to have been worked below the site, possibly by longwall workings. The void recorded within borehole R3 is interpreted to be representative of a roadway within the former mine workings of the coal seam. It is considered possible that the remaining boreholes recorded collapsed conditions and hence other intact open roadways may exist.

- 12.3.7 Using the criteria stated above the minimum rock cover required above the shallowest worked seam the Upper Coal would be 13 m of rock (1.5 m x 8 m). In such circumstances the available information indicates that there is insufficient rock cover to preclude the site from surface instability due to mining. In such circumstances we would recommend the workings are stabilised by drilling and pressure grouting.

- 13.4.1 It is concluded the site is subject to potential surface instability due to shallow abandoned mineworkings in the Lower Drumgray Coal. Stabilisation of the mineworkings is recommended by means of drilling and pressure grouting.
