# FALKIRK COUNCIL HEADQUARTERS

## Accessibility & Parking Review

**PROJECT NO. 70087380**

**DATE: SEPTEMBER 2021**

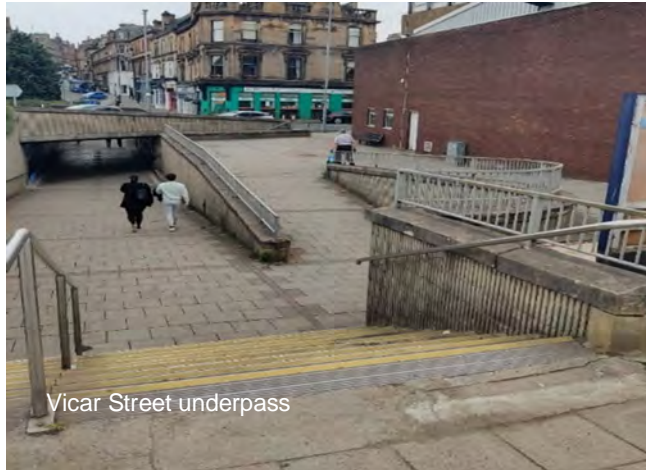
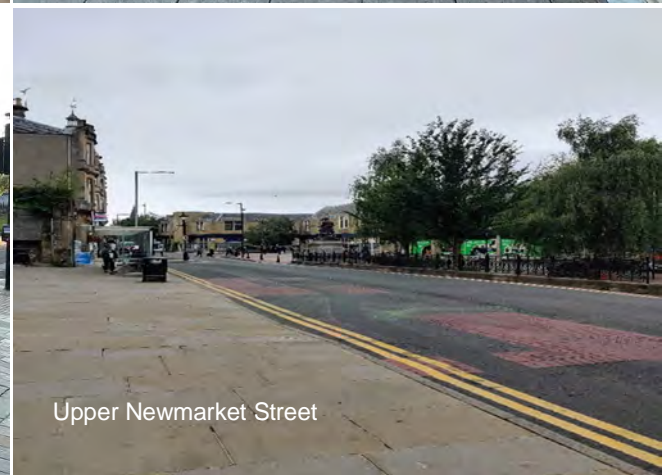
## ROUTE 1R

- 2.2.5. **Description:** The route travels from Falkirk Grahamston Station southwards for a distance of 480 metres and is primarily made up of footways running adjacent to the carriageway.

- 2.2.6. **Surface Quality:** Starting at Vicar Street, the paving consists of large slabs in good condition. This level of provision is continued at the anti-slip protected stairs and ramp through the underpass where adequate handrails are provided.

- 2.2.7. Along Vicar Street, the paving transitions into a smaller tiled high-quality surface. The pavement is free from obstructions, except for one bus stop cage where the usable pedestrian space is temporarily narrowed and where waiting bus users and signage/plants outside the North Star Cafe appear to block parts of the footway.

- 2.2.8. At the Vicar Street / Newmarket Street junction, the high-quality smooth surface continues across the staggered crossing onto the south side of Newmarket Street. Along Newmarket Street, the footway widens, and surface type changes back to large slabs past the St. Andrews bus stop.

- 2.2.9. The paving continues onto Lint Riggs with the addition of finer brick paving separated by bollards and shallow drainage gutters. From here, the full width of the pedestrian area can be utilised with the exception of outdoors café/restaurant seating and bike stands.

- 2.2.10. **Lighting:** Lighting is provided by streetlights along Vicar Street while the north entrance to the underpass does not have dedicated lighting. The underpass itself has lighting installed.
- 2.2.11. On Vicar street past the underpass, the lights in combination with the light grey colour of the paving aids with visibility.
- 2.2.12. **Crossings:** Dropped kerbs are provided when crossing Melville Street going south and when crossing Vicar Street itself at certain locations however, no formal crossing provision is provided.
- 2.2.13. The Vicar Street / Newmarket Street staggered signalised crossing does force pedestrians to deviate and the pedestrian island is relatively narrow and so does not enable many pedestrians to wait.
- 2.2.14. **Directness:** The route takes a direct path from the train station to the Cockburn Street / High Street Site.

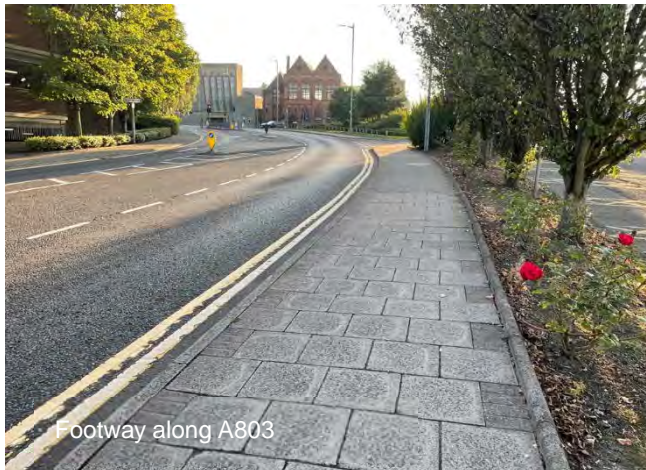
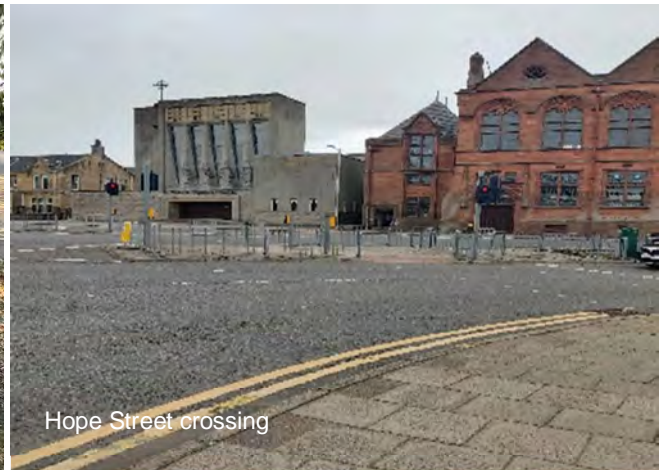
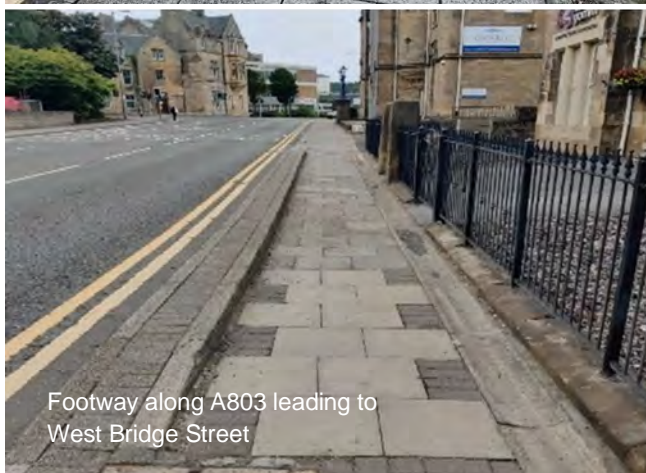
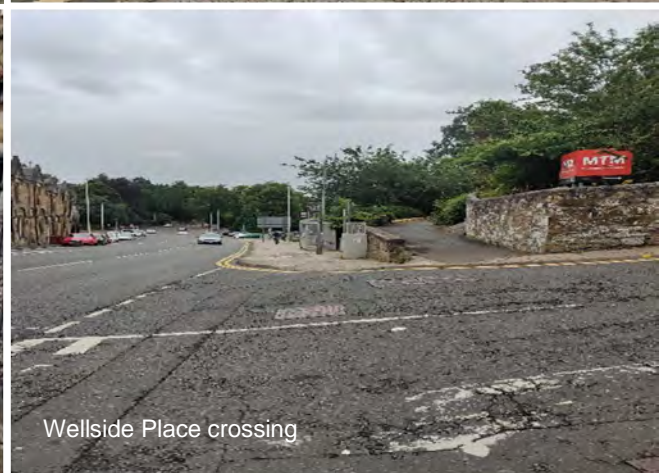
## ROUTE 2R

- 2.2.15. **Description:** The route travels south-west from Falkirk Grahamston Station for a distance of 580 metres and primarily consists of footways running adjacent to the carriageway.

- 2.2.16. **Surface Quality:** From the A803, the surface quality and type of paving differs with smooth paved slabs, bricks and asphalt freely mixed. The paving is intact with little damage or cracks present.

- 2.2.17. At the access roads into the Party Rocks (retail outlet) parking, dropped kerbs with tactile paving are provided however, uneven surfaces on the road allows for dust and gravel to collect which could cause problems for pedestrians utilising the dropped kerbs. The width of the A803 footway is approximately 1.5 metres allowing for two people to pass each other.

- 2.2.18. Going onto Hope Street, a small section of faded red colourised asphalt indicates an informal crossing complimented by tactile paving. Going south along A803, uneven surfaces outside the vehicle access to properties appears to cause the build-up of gravel and dirt on the footway. The footway in places is partially obstructed by electrical cabinets, lighting columns and a short section of raised kerb that narrows the footway by approximately 30 centimetres.

- 2.2.19. On West Bridge Street, the footway widens, and the surface material alters to paving slabs which are present for the remainder of the route. Occasional cracks and obvious prior replacement of slabs is visible along with several service hatches of various sizes. At the pedestrian crossing on Wellside Place, there is uneven surfacing materials which is contributing to the collection of dirt.

- 2.2.20. The access road from West Bridge Street to the existing Municipal Buildings Site has an asphalt surface and pedestrian guardrail provides segregation from general traffic.

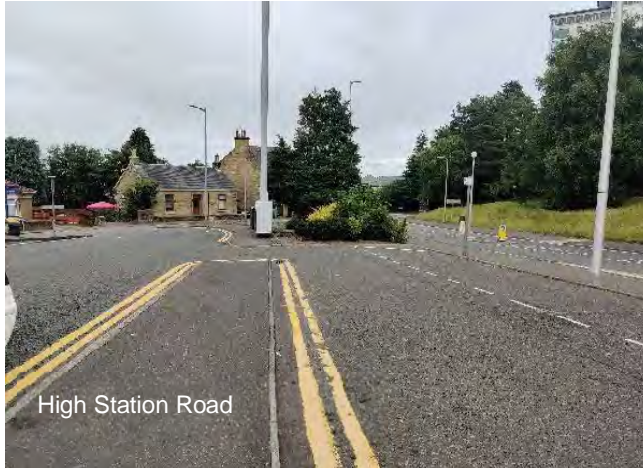
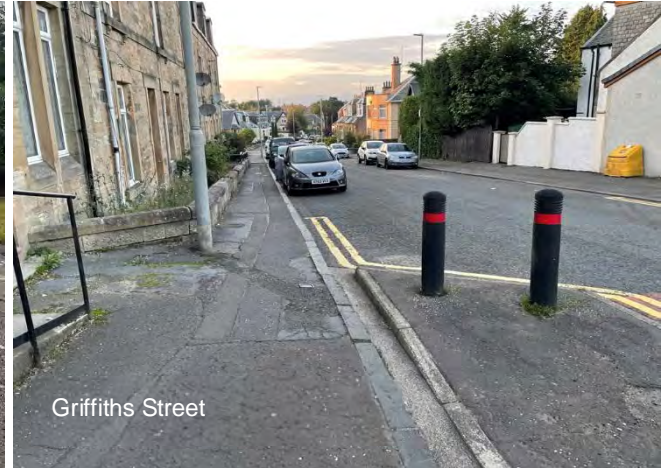
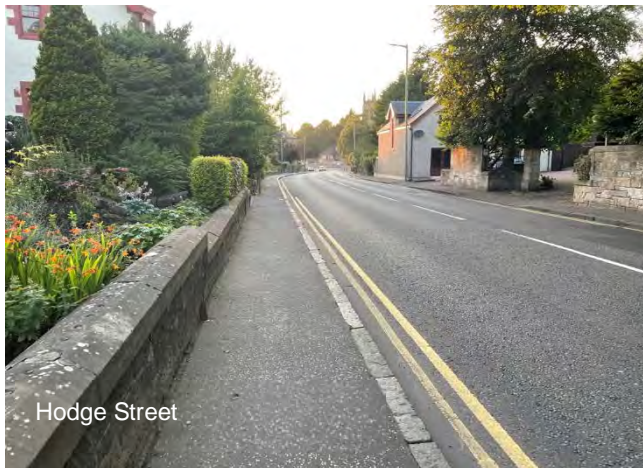
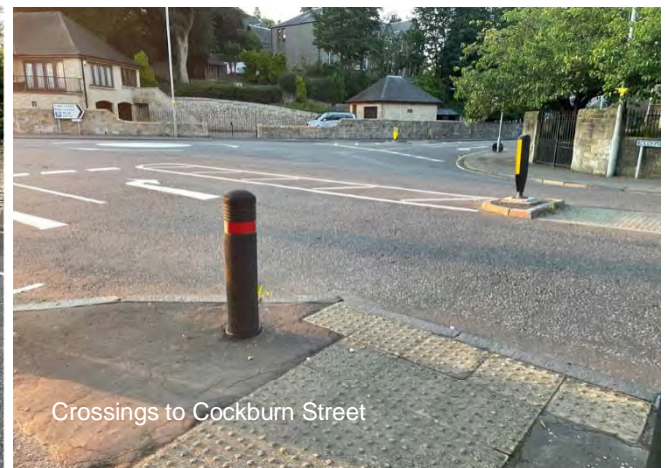
## ROUTE 3R

- 2.2.28. **Description:** The route travels northwards from Falkirk High Station for a distance of 1,280m, with the route predominantly running adjacent to the carriageway.

- 2.2.29. **Surface Quality:** The route starts with asphalt paved footway along High Station Road. Overhanging vegetation from properties, electrical cabinets, bus stops and public bins occasionally obstructs and limit the available space for pedestrians. Cracks and damage in the pavement can be observed at entrances to properties, crossings and dropped kerbs. This all contributes to the uneven surface of the approximately 1.5 metre wide footway.

- 2.2.30. The paving at the Gartcows Road crossing has tactile paving and dropped kerbs. Continuing down High Station Road to Griffiths Street asphalt paving is continued, no vegetation is present, and the pavement widens outside the business establishments.

- 2.2.31. The footway on Griffiths Street is narrower than on High Station Road and vegetation from residential properties was seen to frequently overhang the footway during the audit. The dropped kerbs are uneven and prone to dirt and gravel collection. The footway is also occasionally obstructed by lighting columns.

- 2.2.33. The footways onwards from the Cockburn Street crossing are asphalt surfaced with a width in excess of 1.5 metres allowing for increased pedestrian flow. This continues on to the Tanners Road underpass, where high quality stairs and ramps enables access onto Bells Wynd and the Cockburn Street / High Street Site.

- 2.2.34. **Lighting:** street lighting on alternating sides of the road is provided along High Station Road, Griffiths Street, Hodge Street and Arnothill Bank. Lighting is absent at the south entrance of the Tanners Road underpass.

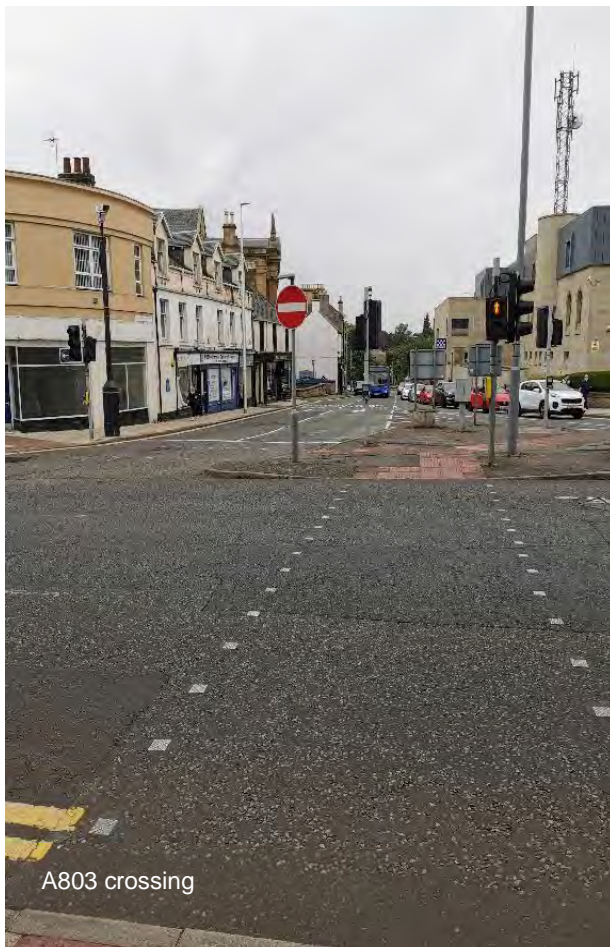
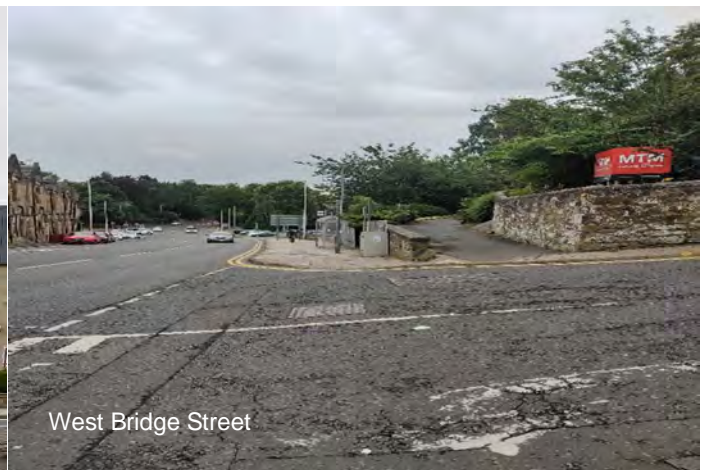
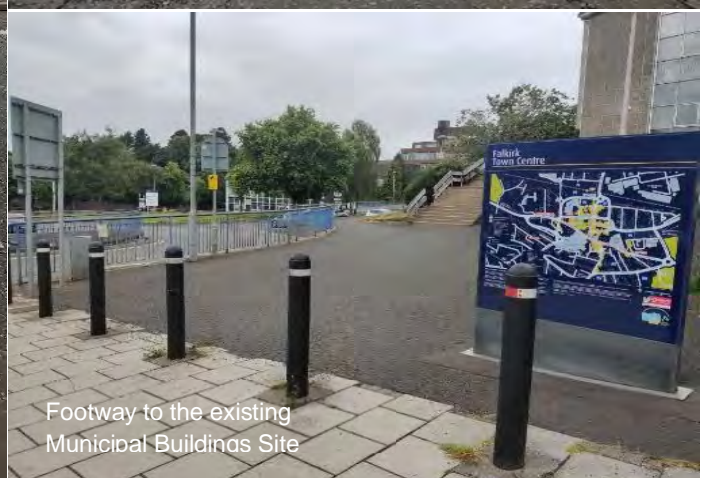
## ROUTE 4R

- 2.2.37. **Description:** The route is a continuation from Route 3R connecting to existing Municipal Buildings Site heading north-east for a distance of 320m. The route runs adjacent to the carriageway.

- 2.2.38. **Surface Quality:** After following Route 3R to Bell's Wynd, an asphalt paved surface takes pedestrians to the Upper Newmarket Street / A803 junction where multiple crossing options are available.

- 2.2.39. A trail of red tactile paving clearly indicates the pedestrian routes between the connecting roads and central pedestrian island. The island itself does have visible damage and cracking which appears prone to collecting dirt and the surfaces are not as smooth as the tiles on the adjacent West Bridge Street and High Street.

- 2.2.40. Along West Bridge Street, the footway widens, and high quality light coloured tiles provide a high quality surface route to the existing Municipal Buildings Site.

- 2.2.41. **Lighting:** The route is lit by streetlights with addition of a light on the pedestrian island which provides good wayfinding at the junction.

- 2.2.42. **Crossings:** There is one crossing on the route, a staggered signalised crossing with tactile paving and dropped kerbs at the Upper Newmarket Street / A803 junction.

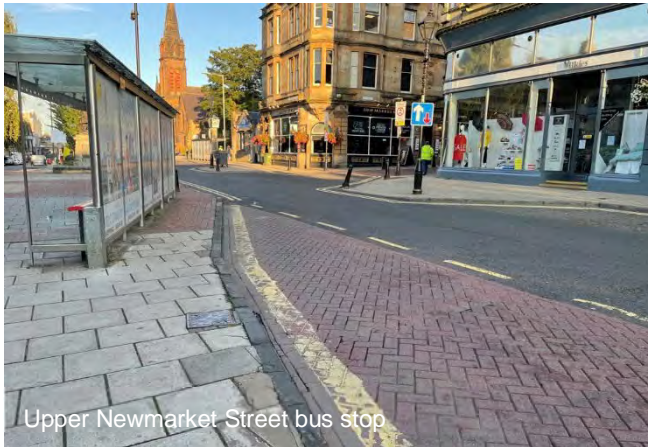
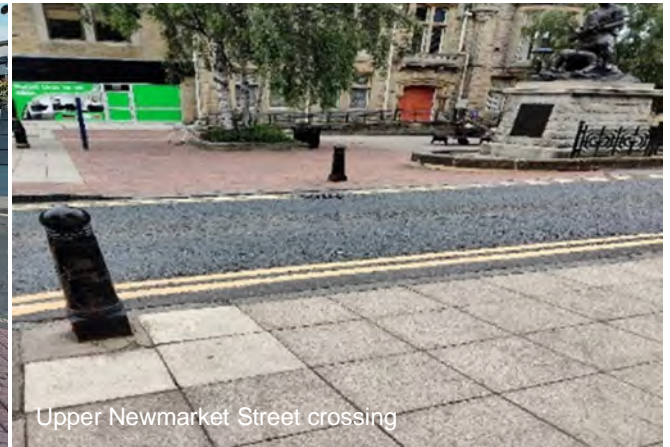
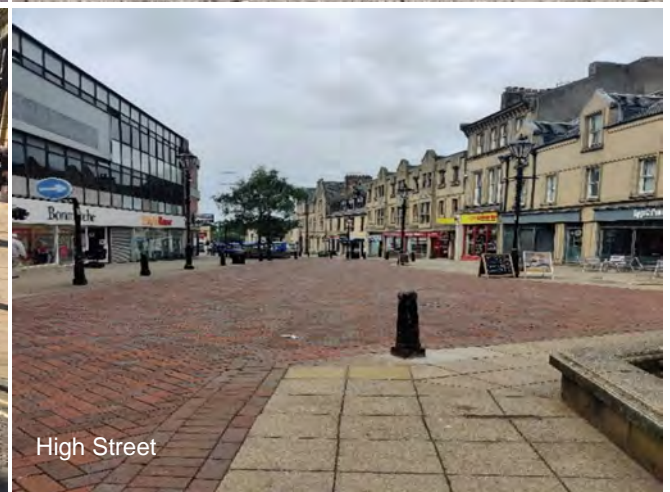
## ROUTE 1B

- 2.2.46. **Description:** The route travels from the bus stops on Upper Newmarket Street southwards for a distance of 140 metres and is predominantly traffic free.

- 2.2.47. **Surface Quality:** The surface materials on Upper Newmarket Street consist mainly of a mix of smooth paved slabs, tiles and asphalt. It is of good quality with no obvious trip hazards due to dropped kerbs. Space is provided for pedestrian movements in all directions in and around the bus stops, Asda and onto Lint Riggs. No obvious obstructions other than occasional bike stands and outdoor serving seating were noted.

- 2.2.48. **Lighting:** The route is well lit in its entirety with a mix of lighting being provided along Upper Newmarket Street, Lint Riggs and High Street.

- 2.2.49. **Crossings:** There is one uncontrolled crossing with dropped kerbs to connect the eastbound bus stop to Lint Riggs. The crossing is also temporarily narrowed to minimise pedestrian activity on the carriageway.

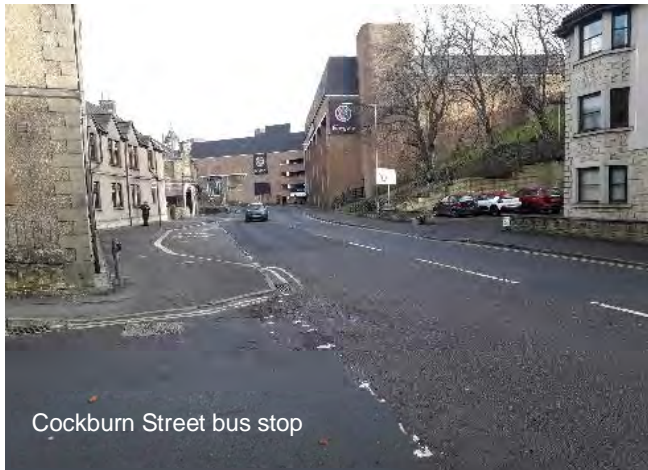
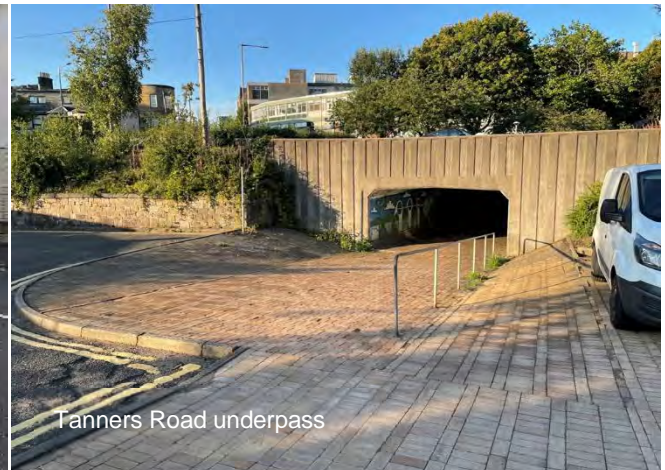
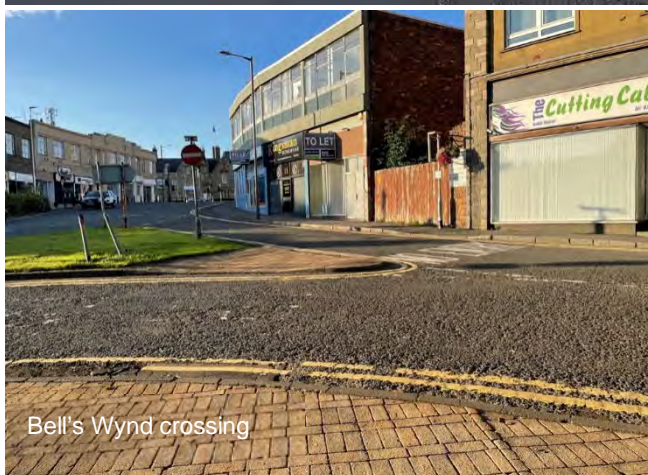
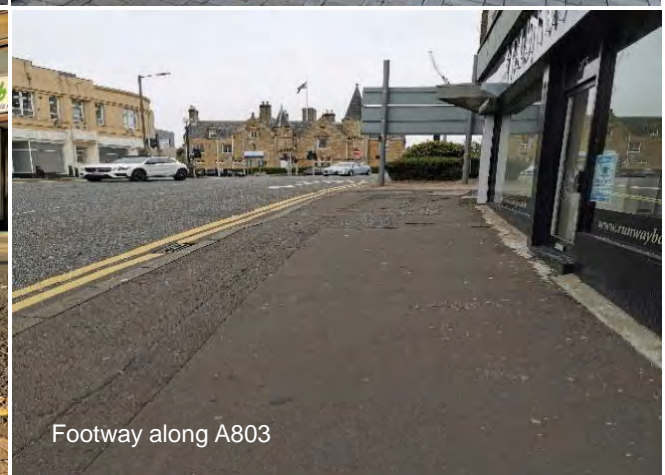
## ROUTE 2B

- 2.2.51. **Description:** The route travels from the bus stop on Cockburn Street northwards for a distance of 320m, with the route predominantly running adjacent to the carriageway.

- 2.2.52. **Surface Quality:** The footways along Arnothill Bank has an asphalt surface and width in excess of 1.5 metres. The crossings at Arnothill and Arnothill Gardens appears to be of poor quality where uneven surfaces and asphalt damage allows for dirt and potential water collection at the dropped kerbs.

- 2.2.53. The footway outside of Blush Hair and Beauty is patched and partially blocked by wheelie bins which could pose tripping hazards. The corner at Blush Hair and Beauty appears to be a pinch point prone to leaves, water and dirt collection. This paving at the Tanners Road underpass consists of smooth high-quality bricked stairs and ramps allows for access onto Bells Wynd and the site. The footway along the A803 is wide and in good condition and offers a smooth transition onto High Street.

- 2.2.54. **Lighting:** The route is predominately well lit with streetlights, with the exception of the entrances to the underpass, where lighting appears to be less prominent.

- 2.2.55. **Crossings:** The route includes two uncontrolled crossings at Arnothill Gardens and Bell's Wynd, both with dropped kerbs.

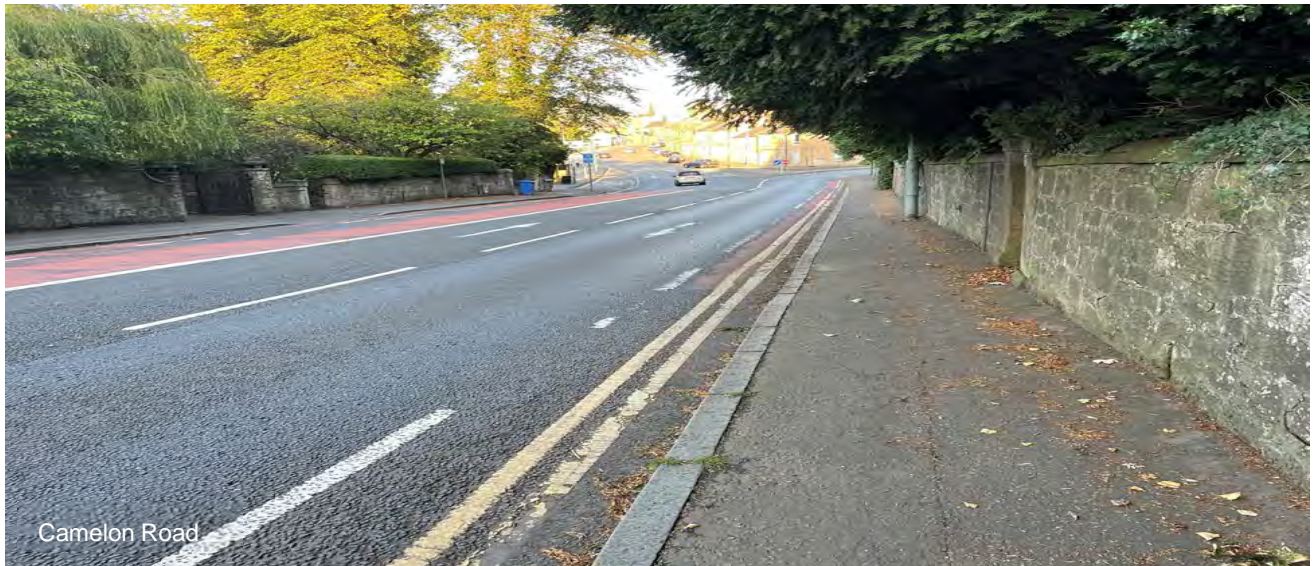
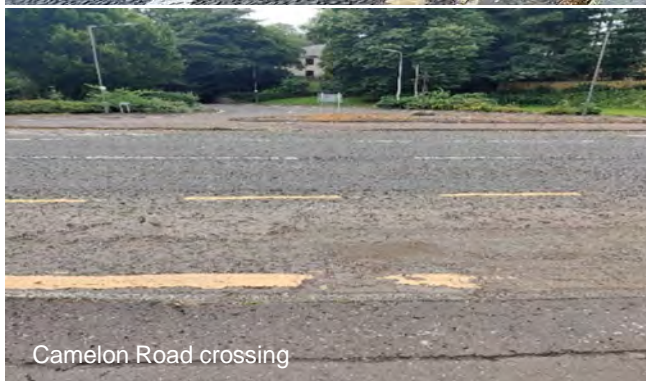
### ROUTE 3B

- 2.2.57. **Description:** The route travels from the bus stops on Camelon Road northwards for a distance of 50 metres and is predominantly traffic free.

- 2.2.58. **Surface Quality:** The surface quality is mixed, consisting mainly of smooth paved slabs. Footway width on Camelon Road appears less than 2 metres and overhanging foliage were observed to impede pedestrians during the audit.
- 2.2.59. **Lighting:** The route is well lit by streetlights however the overhanging vegetation could impact visibility during summer months in the hours of darkness.
- 2.2.60. **Crossings:** The route includes two uncontrolled crossing at Camelon Road and Ferguson Drive, both with dropped kerbs. The lack of formal crossing on Camelon Road to connect the westbound bus services is a gap in provision, should footfall intensify.
- 2.2.61. **Directness:** The route takes a very direct path from the eastbound bus stops on Camelon Road to the existing Municipal Buildings Site however the westbound bus stop could benefit from improved crossings.
