Site walkover survey – aide memoire

Site name: LAND SOUTH OF WESTER BONHARD

Address: PLOT SOUTH OF WESTER BONHARD
BO'NESS
EH51 9RR

Date inspection undertaken: 9 JUNE 2016

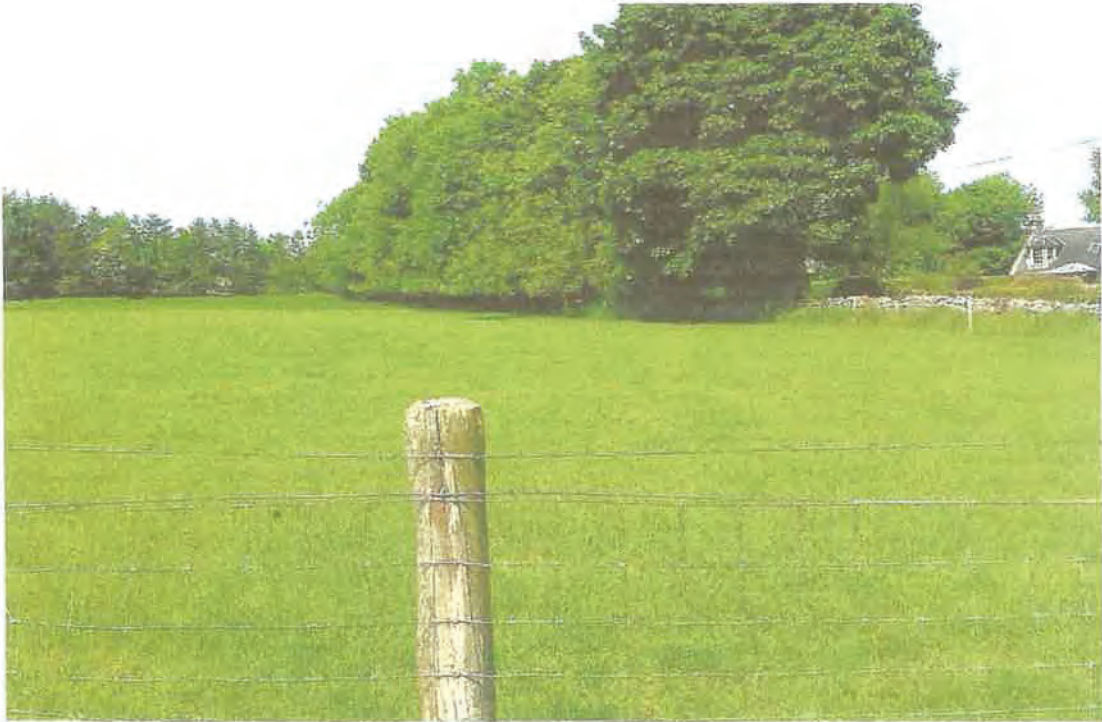
PHOTO 2 - BONHARD - SITE VIEWED E TO W
WITH WESTER BONHARD TO THE RIGHT OF
PICTURE & N OF THE SITE
SITE IN FOREGROUND

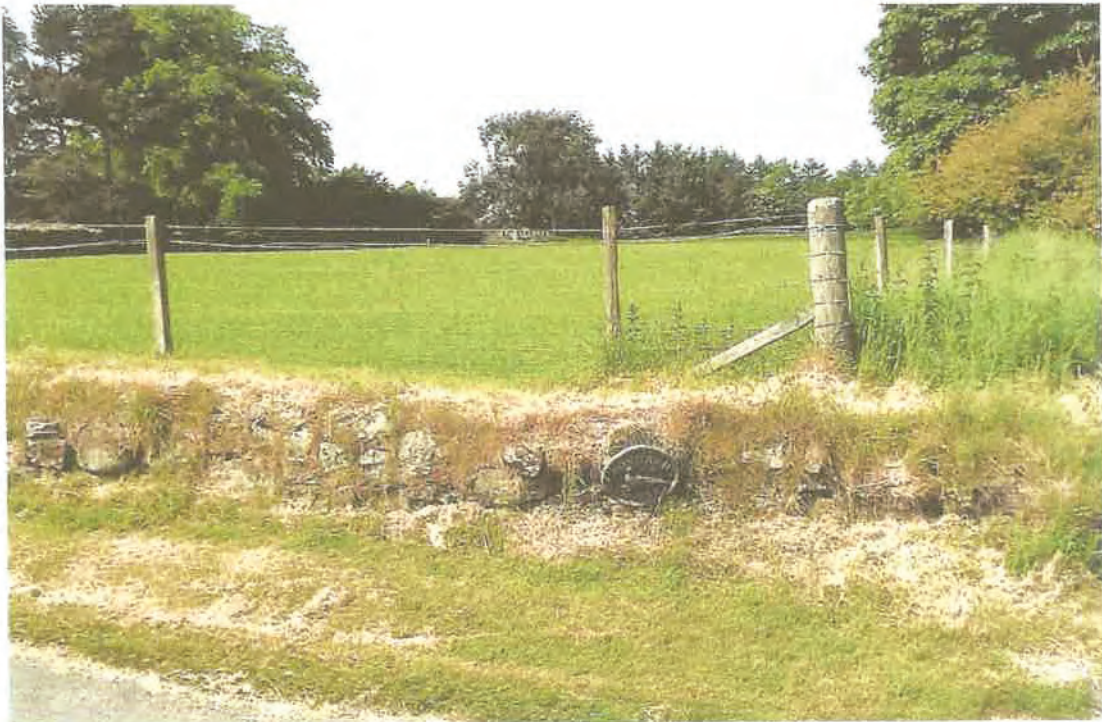
PHOTO 1 - BONHARD - SITE VIEWED FROM ROAD
TO E LOOKING TO SW, NOTE MATURE
TREES TO S, FAR W AND TO N.

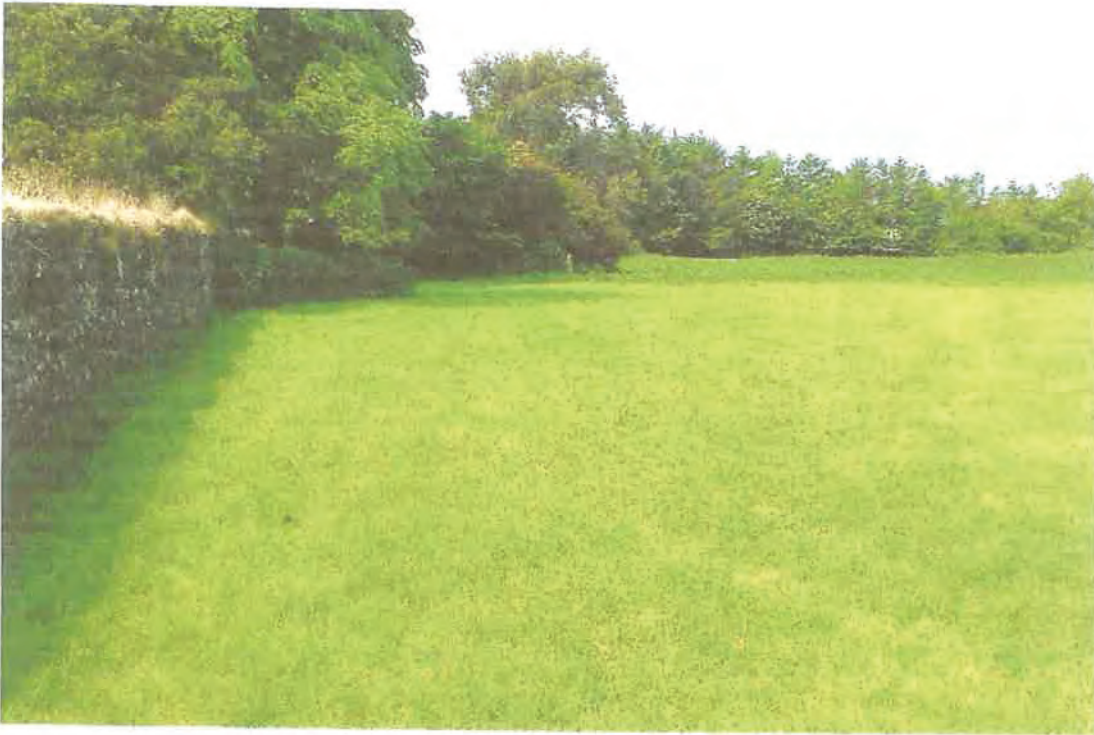
PHOTO 4 - BONHARD HOUSE OUT OF PICTURE
TO LEFT OF BOUNDARY WALL (SOUTH)
MATURE TREES ALONG BOUNDARY AND
AT FAR WEST BOUNDARY TO BACKGROUND.

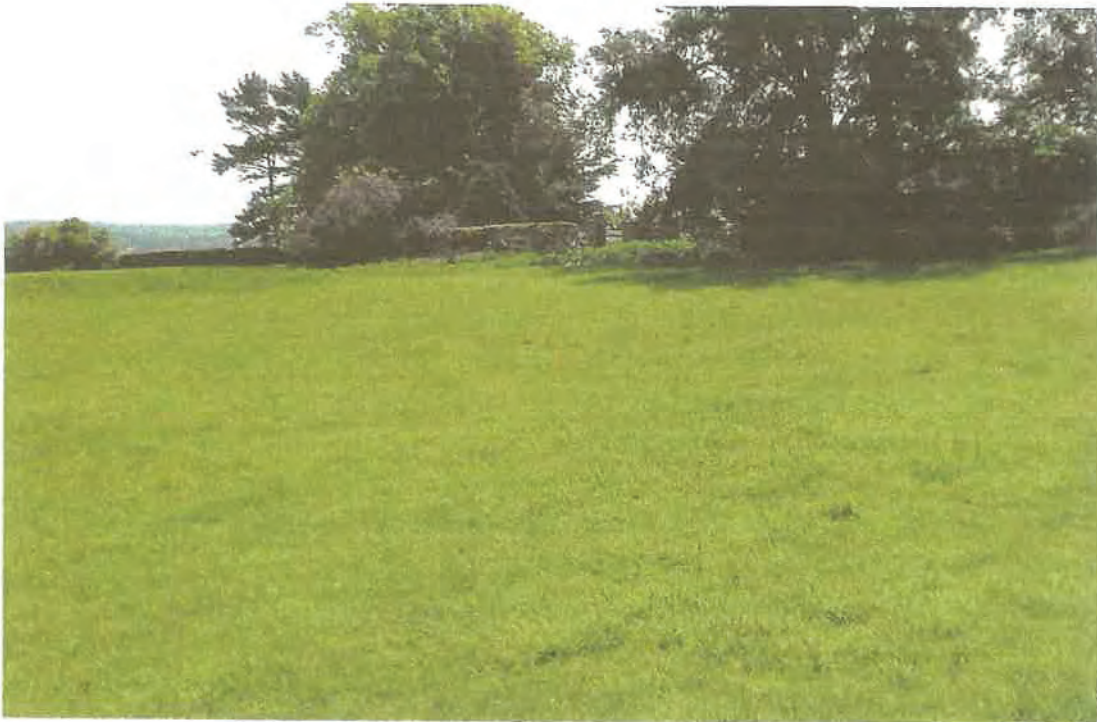
PHOTO 3 - SOUTH BOUNDARY OF SITE WITH
MATURE TREES & HEDGING AND SUBSTANTIAL
STONE WALLS.
SITE IN FOREGROUND

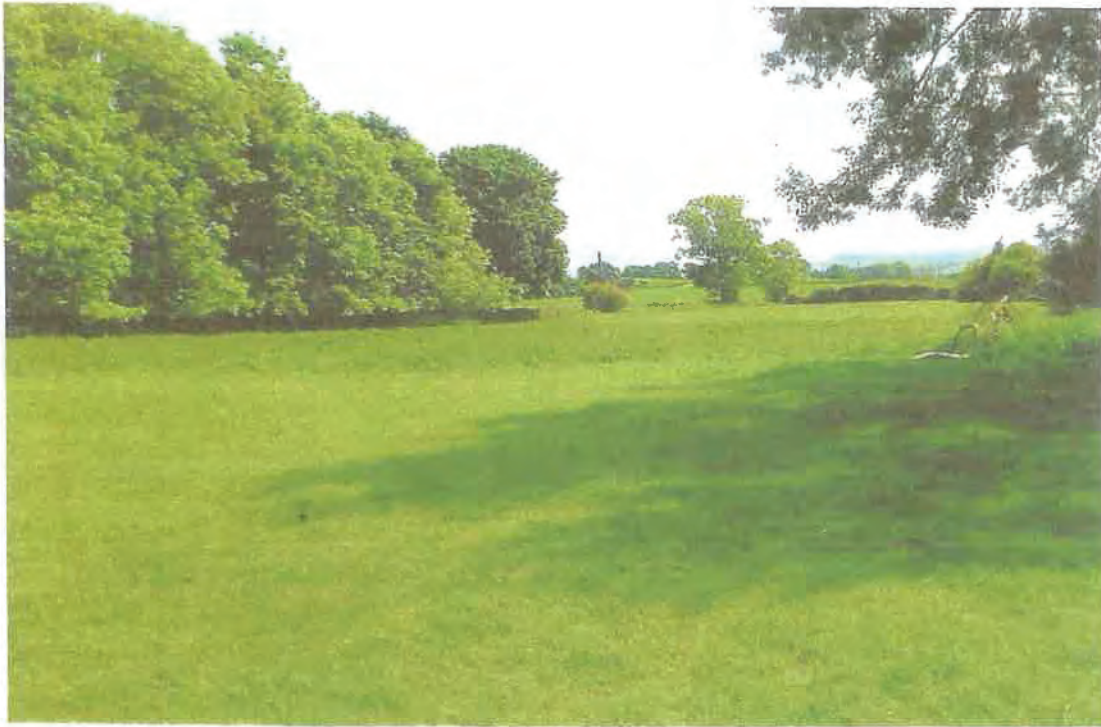
PHOTO 6 - BONHARD - LOOKING FROM W TO THE EAST WITH NORTHMOST BOUNDARY TO LEFT & SOUTH BOUNDARY TO RIGHT BOTH WITH HEALTHY MATURE TREES

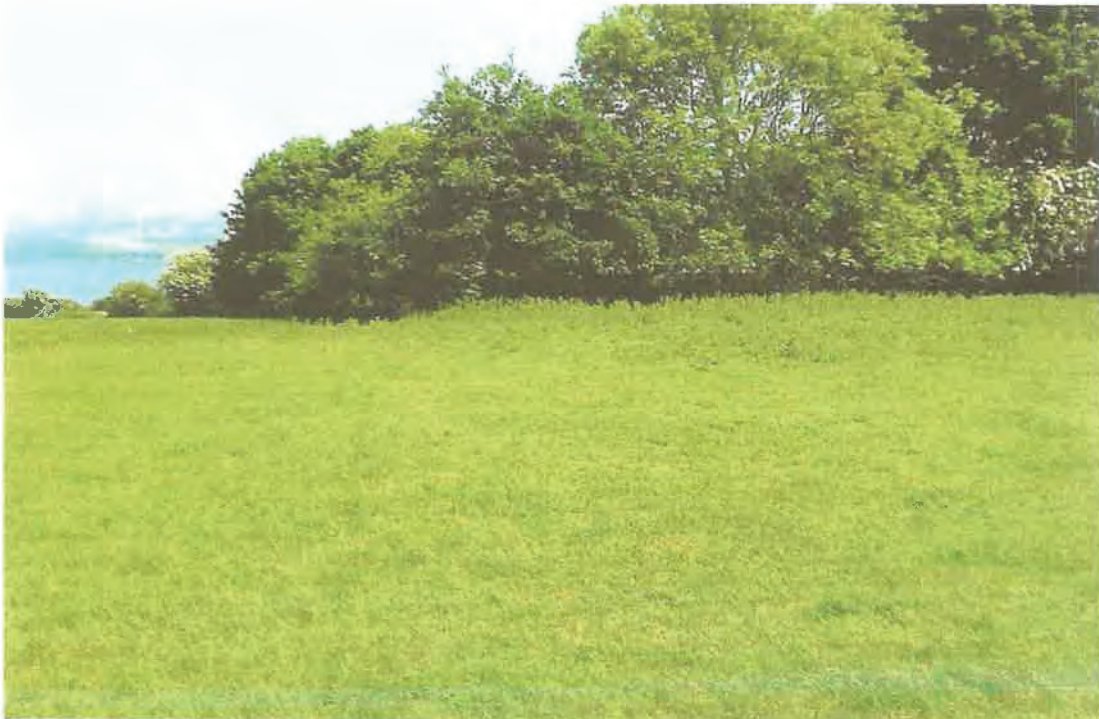
PHOTO 5 - BONHARD - LOOKING N FROM WESTMOST AREA OF SITE - MATURE TREES ALONG BOUNDARY TO ROAD WITH WESTER BONHARD BEYOND
