Plate 1a: Culvert C1 – outlet / downstream face

Appendix D: Model sections

MINING STABILITY REPORT

MINING STABILITY OF SITE AT STANDBURN

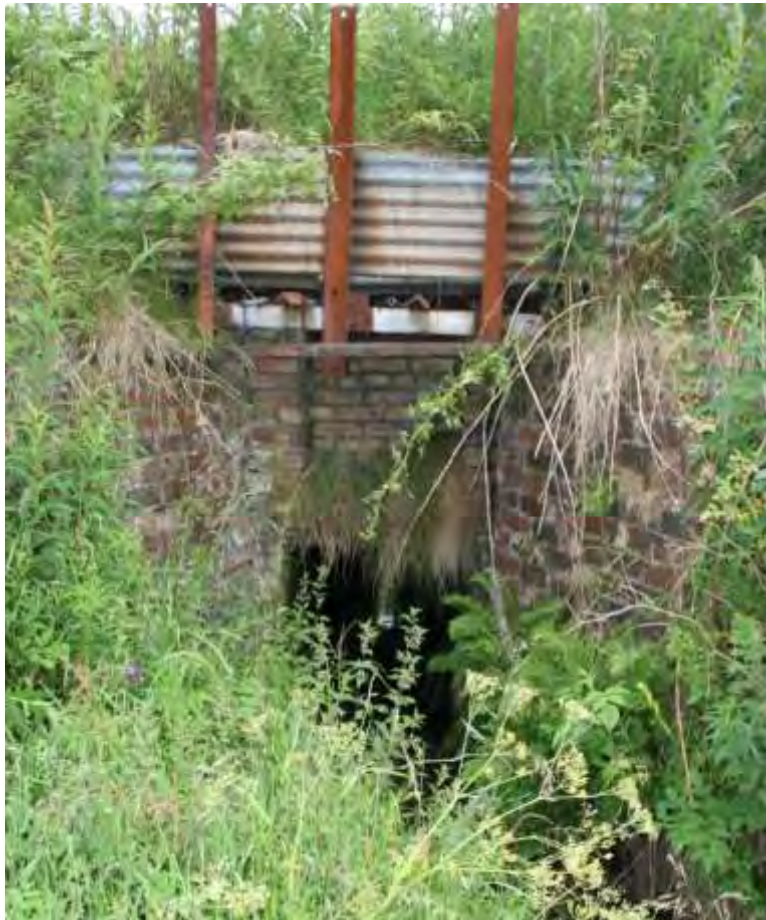
Brick arch

Smaller rectangular frame
(steel) acting as an orifice at
each end

1.05m high / 0.92m wide

Stream exits culvert at a right-
angled bend

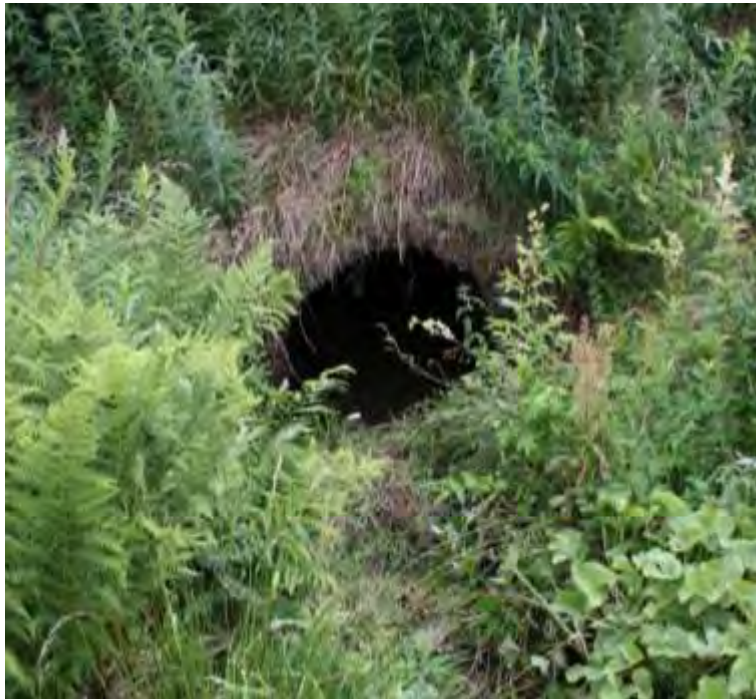
Plate 2a: Culvert C2 – inlet / upstream face

Brick arch
Good condition

1.00m high / 1.08m wide

Culvert was repaired after
breaking in of roof roughly
halfway between inflow and
outlet

A 0.5m wide tributary / drain
joins the burn from the south a
short distance upstream of C2

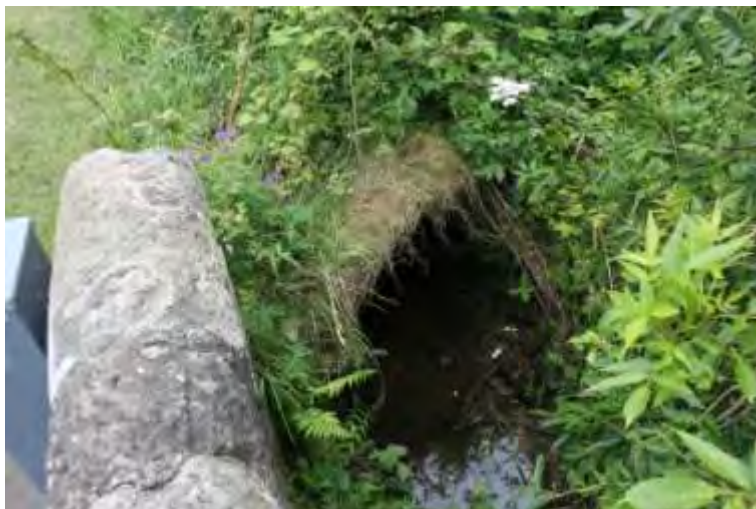
Plate 2b: Culvert C2 – outlet / downstream face

Brick arch
Good condition

0.80m high / 1.07m wide

It appears that a base was added
to the downstream end of the
culvert, perhaps as part of
repair or scour protection. No
flow through culvert on day of
survey.

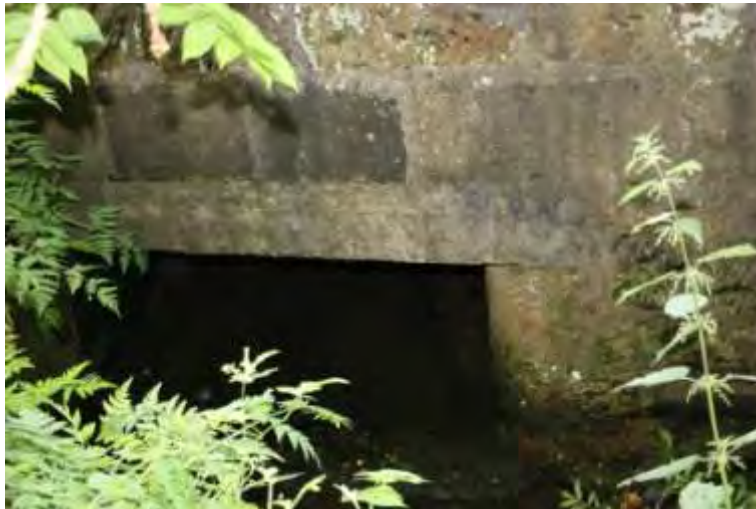
Plate 3a: Culvert C3 – inlet / upstream face

Finished stone sided rectangle

Concrete slab roof and concrete base

0.87m high / 1.75m wide

Right angled turn of burn into culvert

Left hand side of burn armoured with low dry stone wall to 1m high

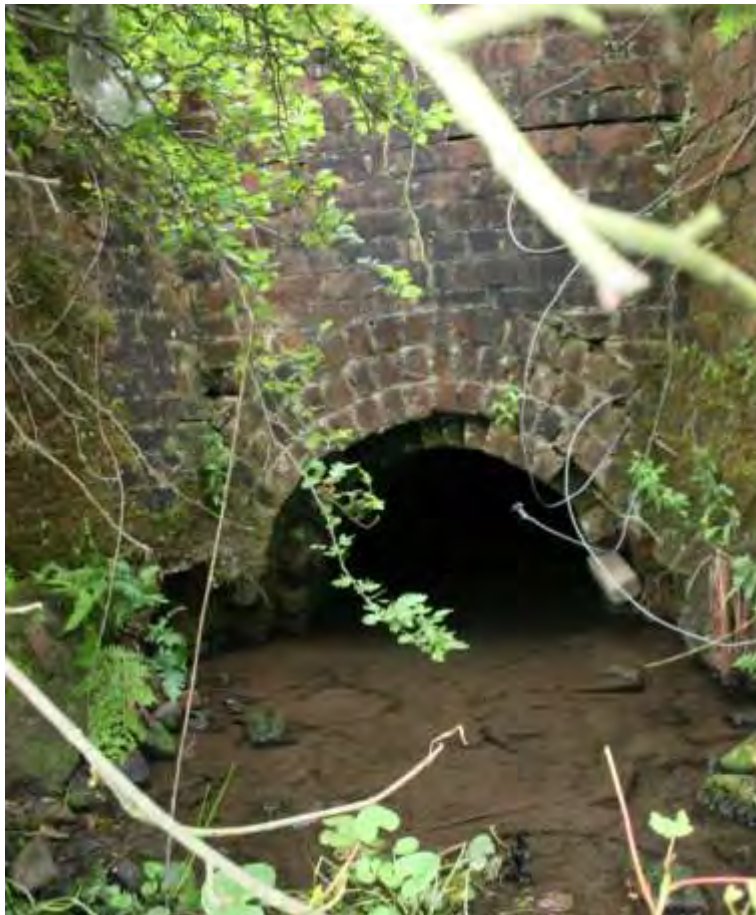
Plate 3b: Culvert C3 – outlet / downstream face

Brick arch

Cemented stone bed finish

1.05m high / 1.20m wide

Culvert shape and direction changes in between

Stream exits culvert at a right-angled bend

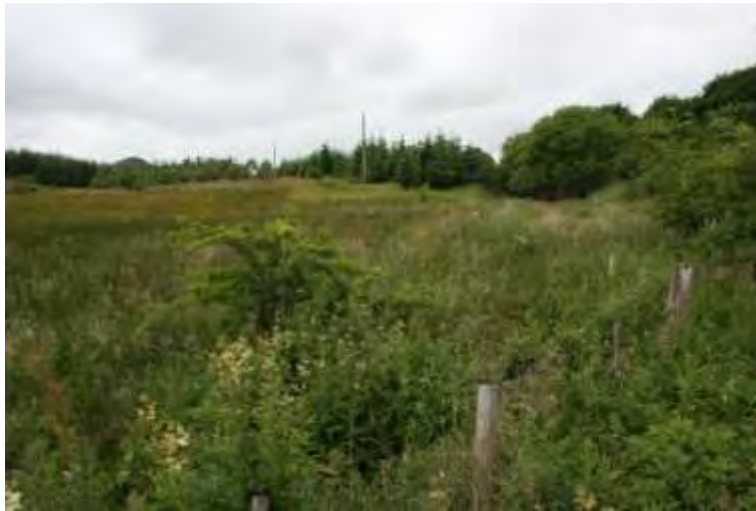
Plate 4: Section 90

Upstream view of wetland
above culvert C2

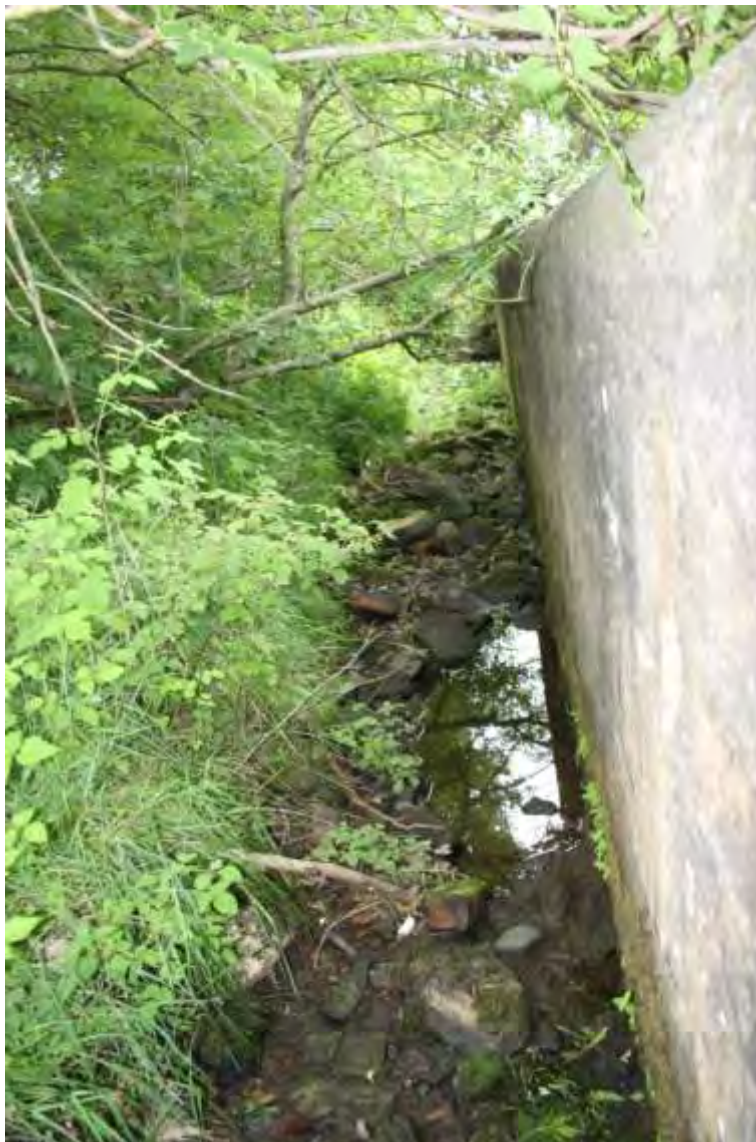
Plate 5: Section between C2 and C3

Wall adjacent to B825 road

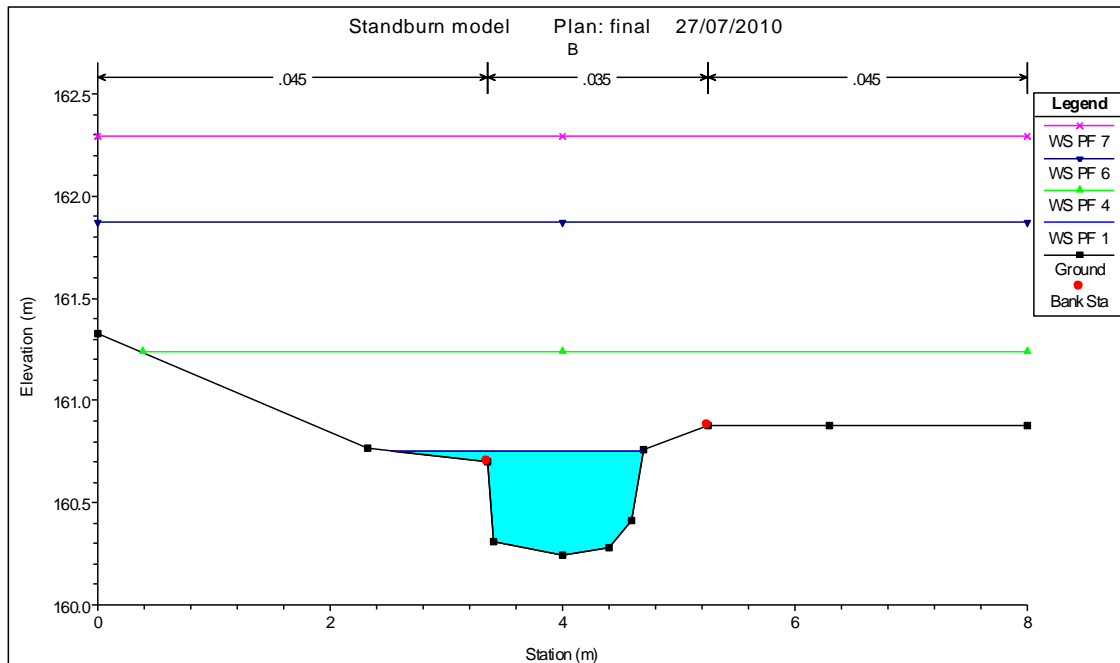
Section 90 – section upstream of culvert C2

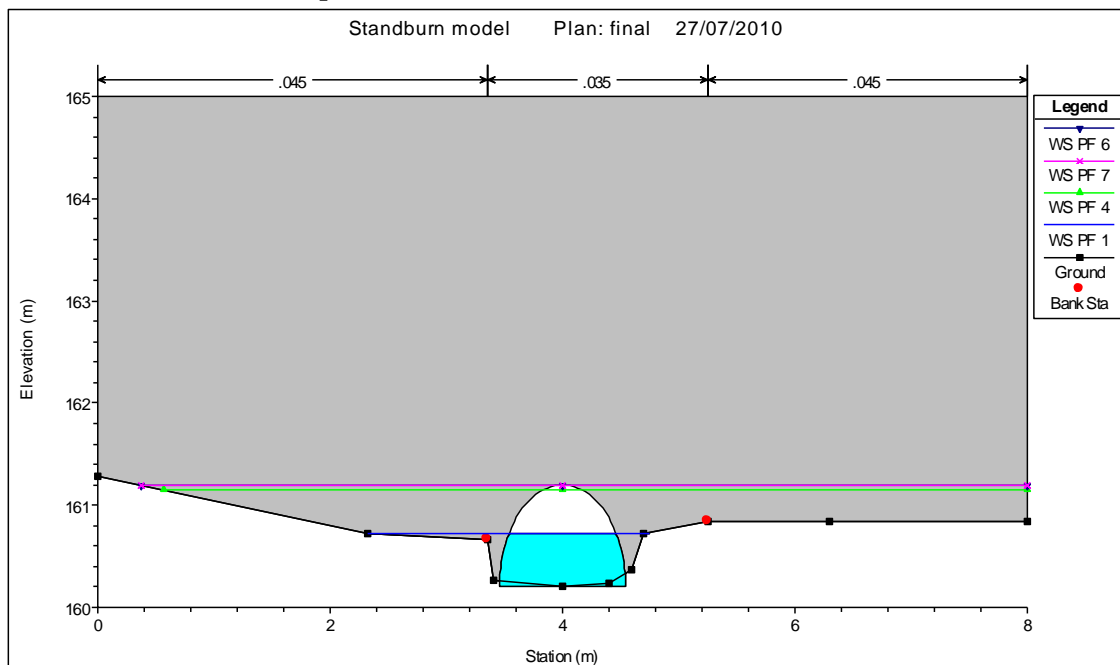
Section 75 – Culvert C2, upstream face

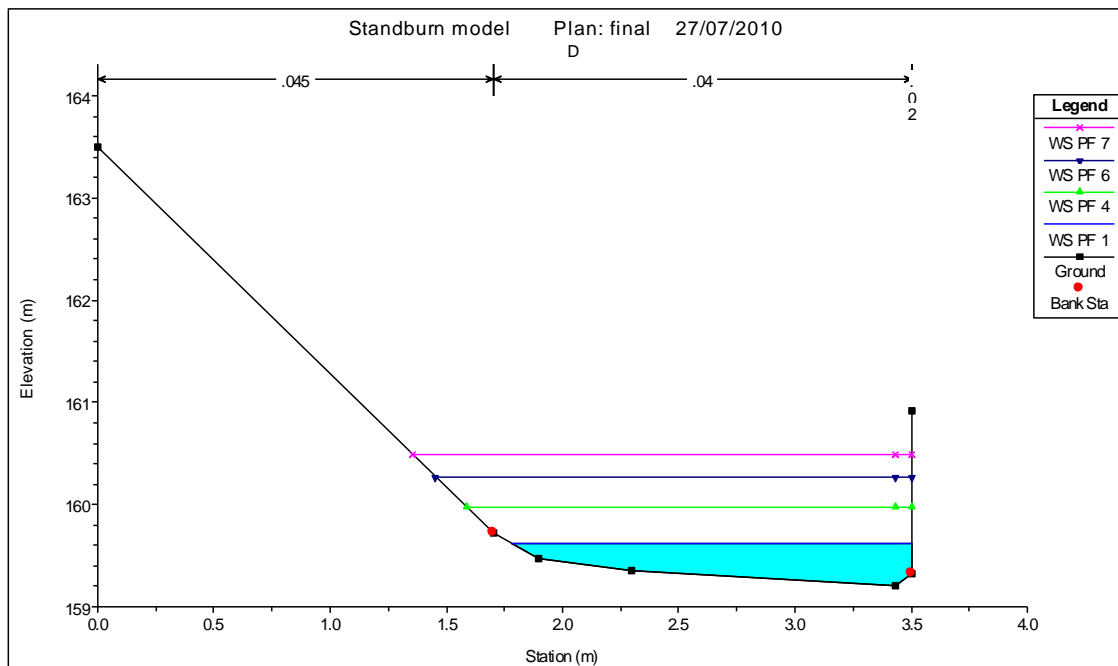
Section 40 – section upstream of culvert C3

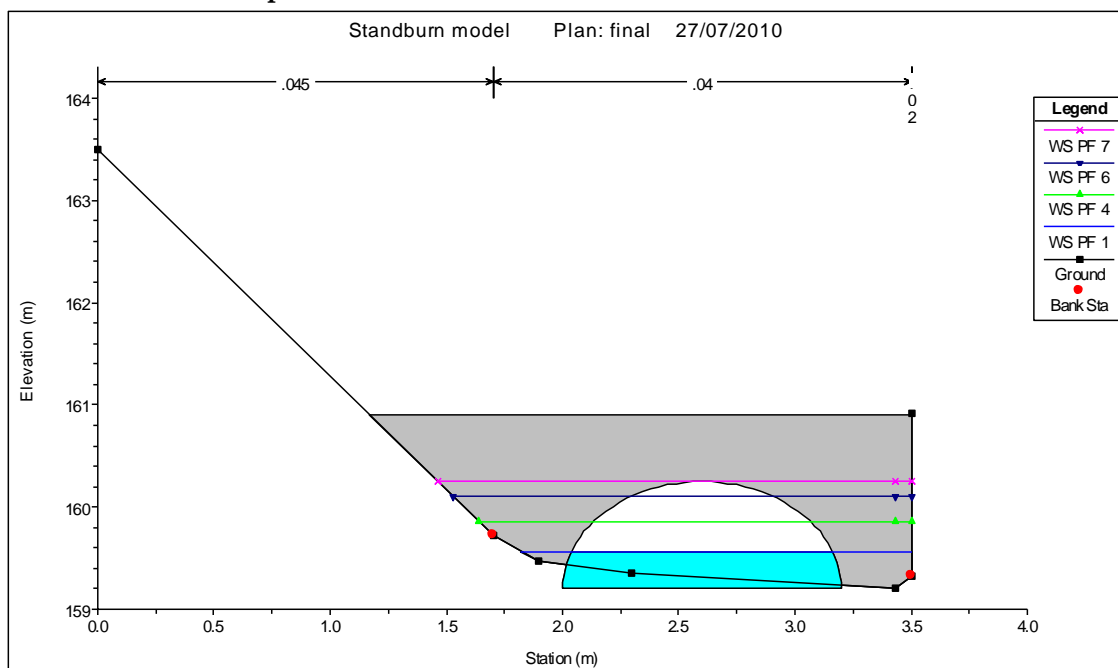
Section 35 – section upstream of culvert C3

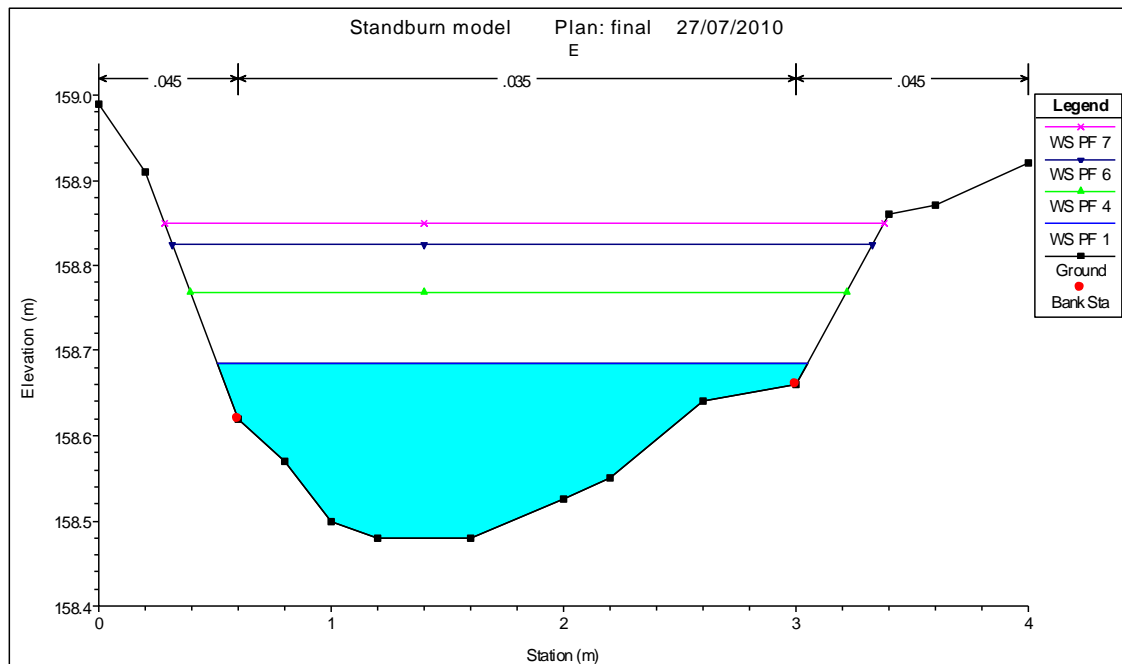
Section 20 – section downstream of culvert C3

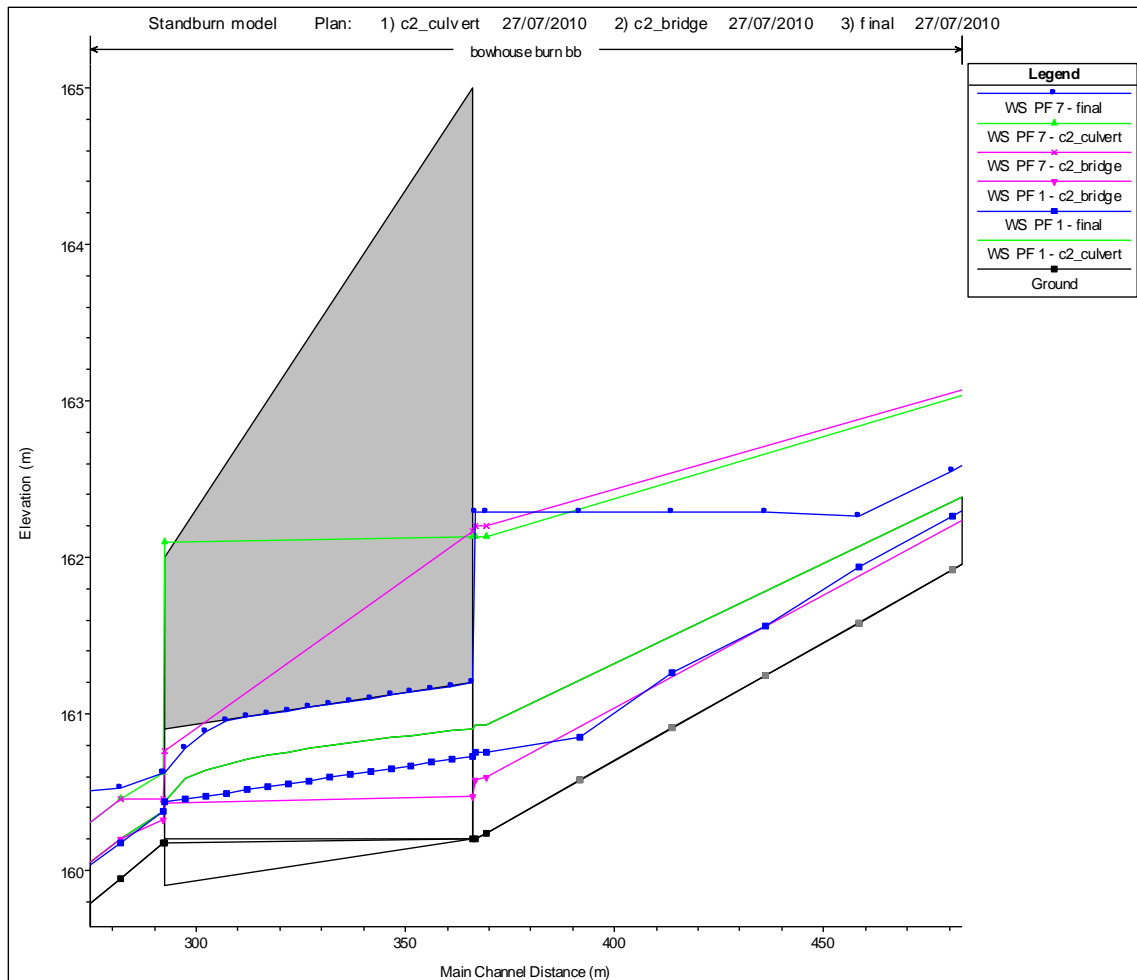
Representation of culvert C2

WS PF 7 – water surface elevation of 200 year + climate change event ($1.5\text{m}^3/\text{s}$)

WS PF 1 – water surface elevation of 2 year event ($0.4\text{m}^3/\text{s}$)

C2_bridge – C2 modelled as a bridge unit with different size openings at inlet and outlet

C2_culvert – C2 modelled as a culvert unit, with a height of 0.8m

final – C2 modelled as a culvert unit, with a height of 1.0m, the invert at the outlet is set 0.2m below the invert of the river bed

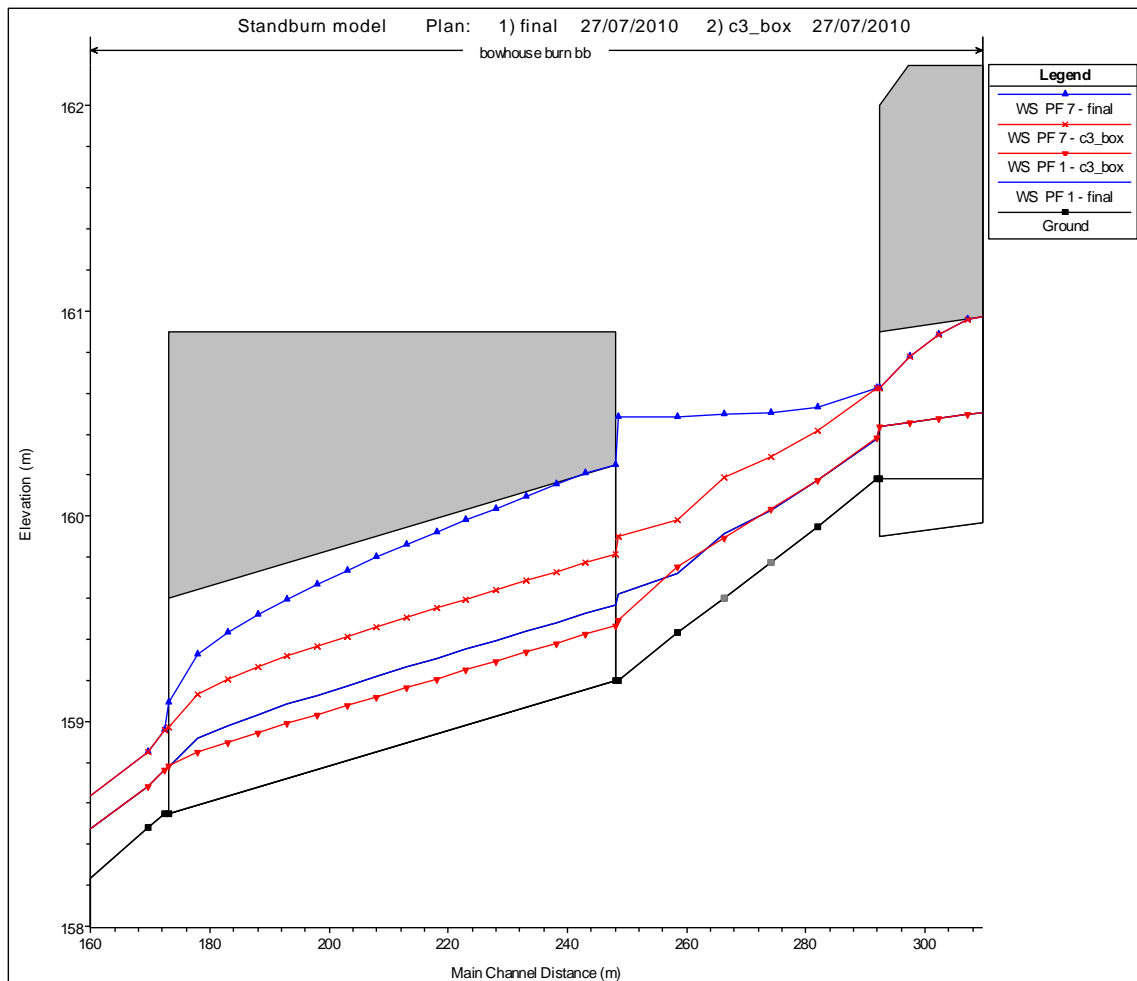
Representation of culvert C3

WS PF 7 - water surface elevation of 200 year + climate change event ($1.5\text{m}^3/\text{s}$)

WS PF 1 - water surface elevation of 2 year event ($0.4\text{m}^3/\text{s}$)

C3_box - C2 modelled as a box culvert unit with dimensions as measured at the inlet throughout
final - C2 modelled as an arch culvert unit with dimensions as measured at the outlet throughout
